Submerged Cultural Resources Study

USS ARIZONA MEMORIAL
and
PEARL HARBOR NATIONAL HISTORIC LANDMARK

by
Daniel J. Lenihan, Editor
Principal Investigator
Submerged Cultural Resources Unit

Southwest Cultural Resources Center Professional Papers
No. 23

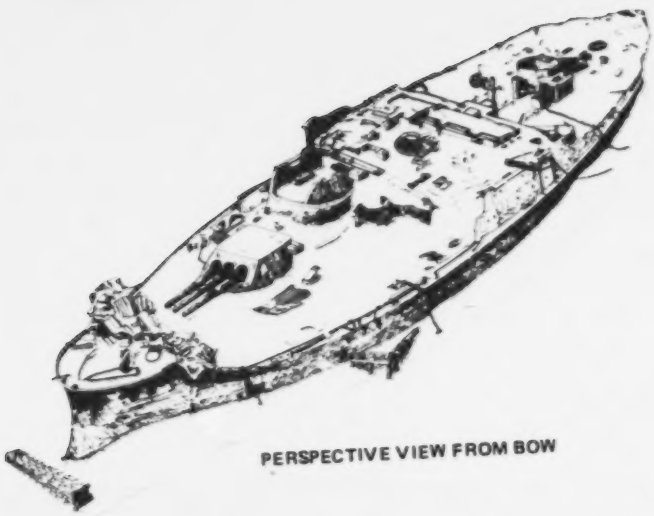
PERSPECTIVE VIEW FROM BOW

On the port side approximately 80 feet and 112 feet aft of the stem, open cracks visible in the torpedo blister continue below the silt line. These cracks in the sides above the silt probably indicate a major structural failure associated with the magazine explosion. In all probability the inner hull and armor belt are also cracked.

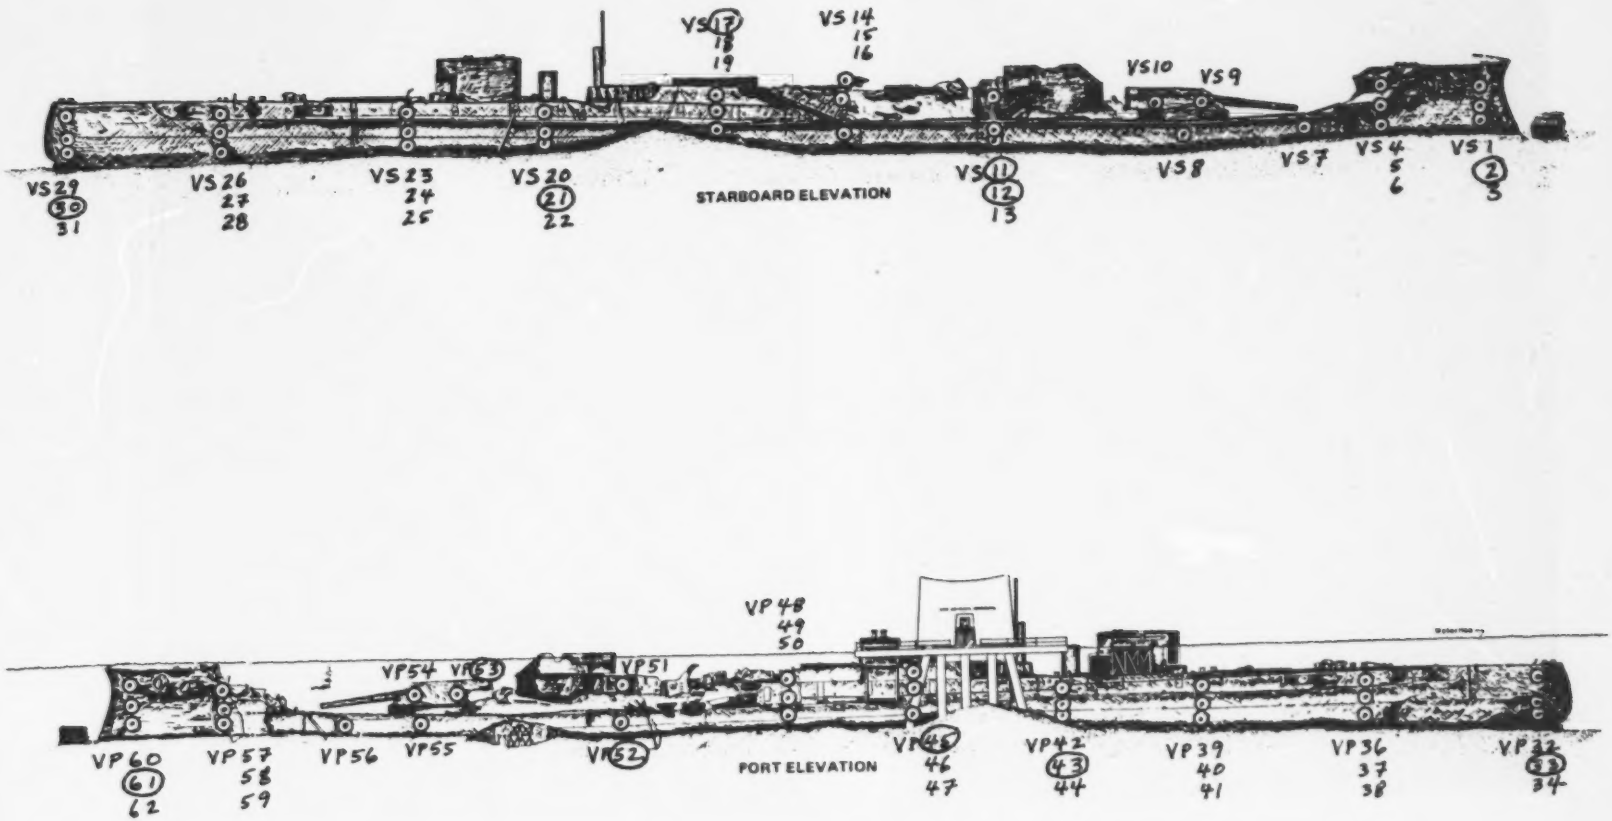
Figure 4.1. Locations of vertical surface biofouling stations on the USS ARIZONA. Encircled station numbers denote permanently emplaced PVC studs for photo monitoring.

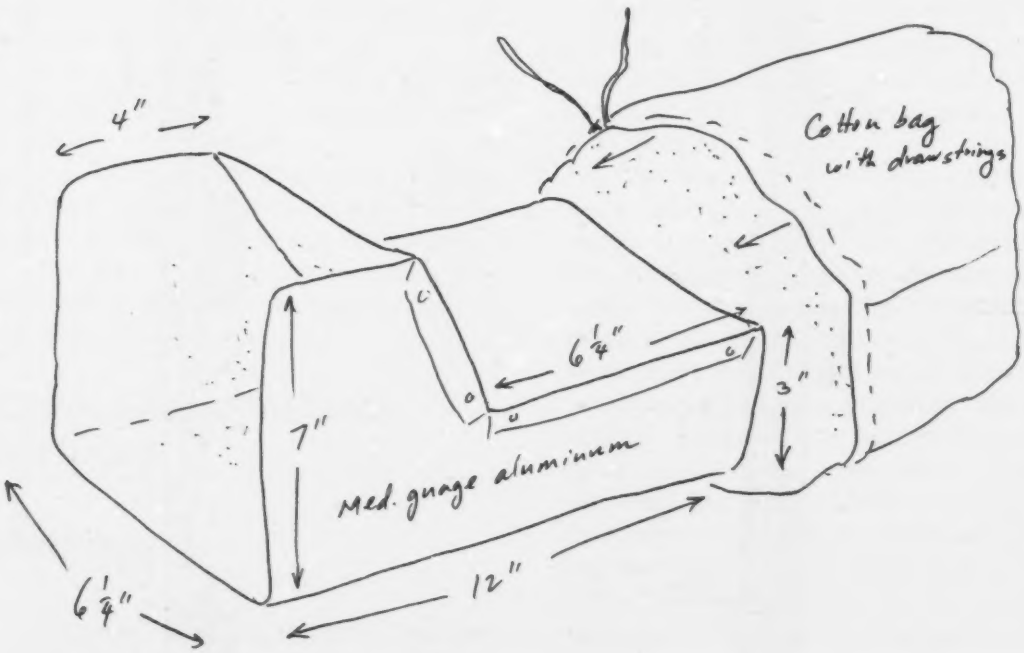
Figure 4.3. Diagram of bioscraping collector funnel.

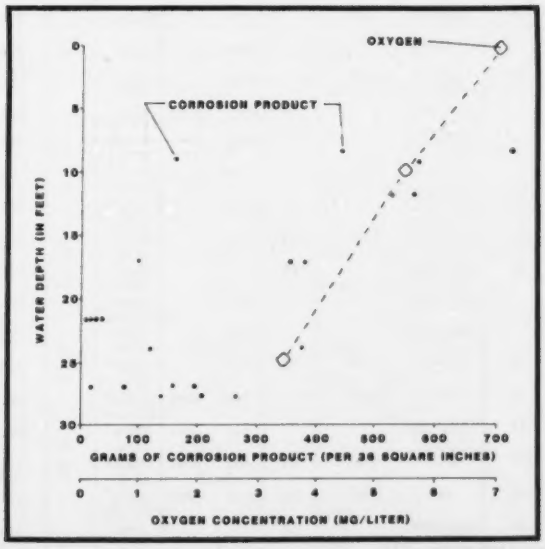
Figure 4.6. Plot of water depth versus grams of corrosion product removed from 36-inch square areas of steel surface at vertical photostations on the USS ARIZONA. For comparative purposes, typical oxygen concentrations that occur at surface and two midwater depths (R.S. Henderson, unpublished Pearl Harbor survey data, 1978-1986) are provided.

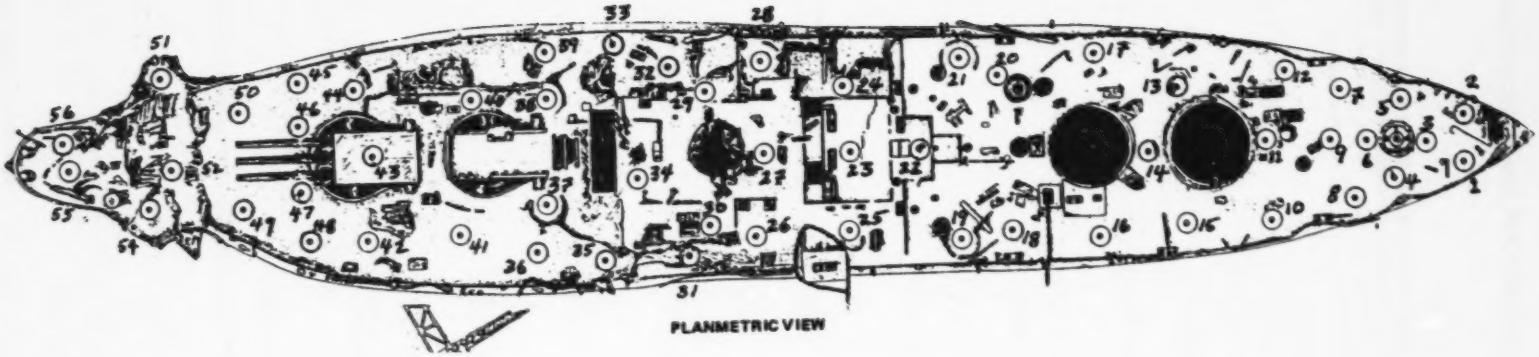
Aft area, about 40 percent of ship length (Stations 1 through 22). This area lies in an average depth of 8 to 10 feet. Sediment is generally 1 to 6 inches deep and is characteristically about 50 percent sand, 20 percent rubble, and 10 percent mud/silt. The sediment is held together in a spongy mat by pervading growth of colonial feather-duster worms (Branchiomma cingulata) and sponges. Large feather-duster worms (Sabellastarte sanctijosephi) inhabit the sediment in densities of about 1 to 5 per square meter. Encrusting and erect spon-

Figure 4.7. Locations of horizontal surface monitoring stations on the USS ARIZONA.

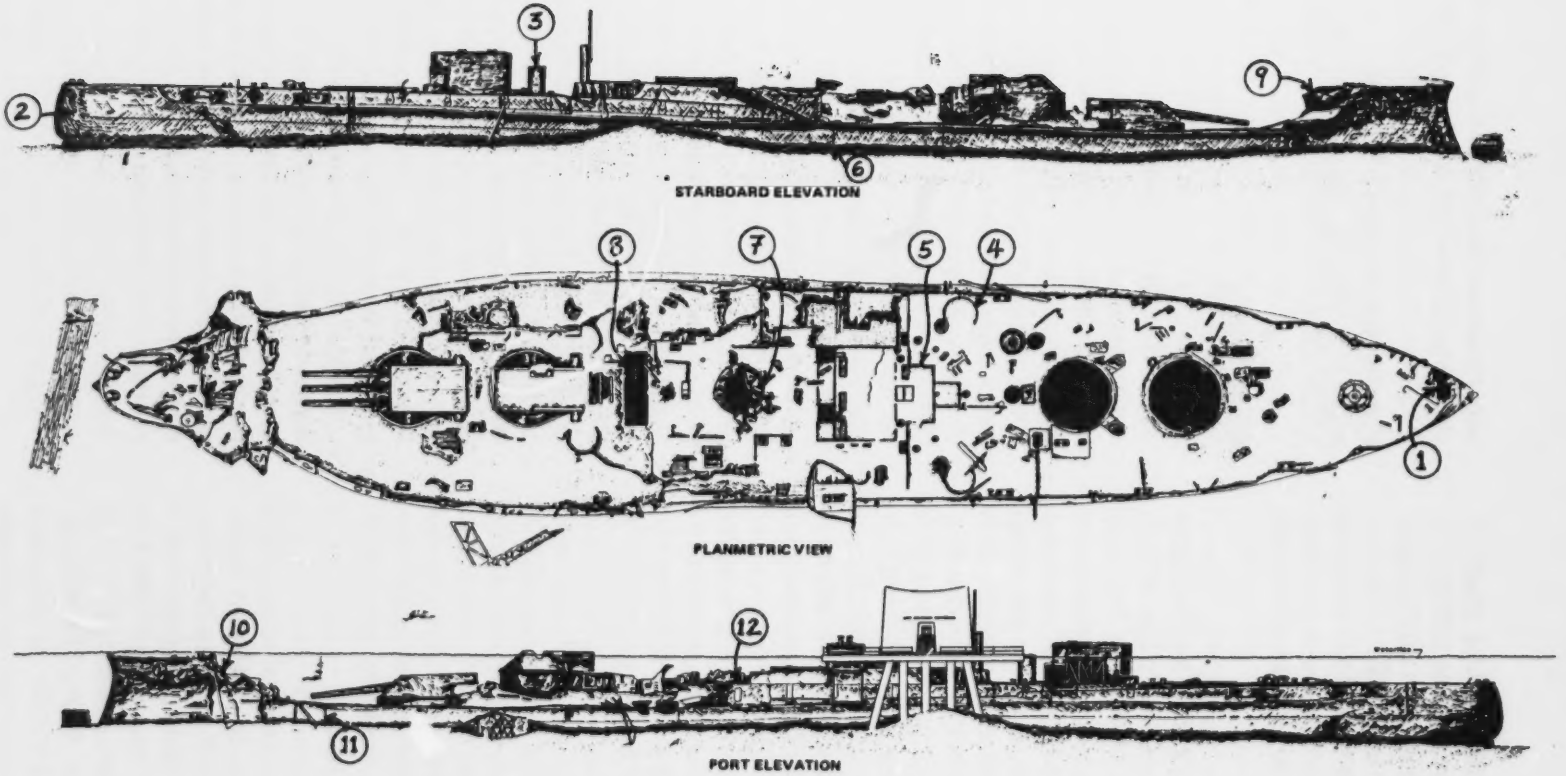
It is recognized that surfaces on or near exposed edges might be affected by edge events that could alter measurements of corrosion, in other words, yielding higher corrosion rates than would occur on large-area flat surfaces. However, since sampling removal of metal pieces from flat areas was not allowed, it was decided to examine the edge corrosion to allow at least a worst-case estimation of corrosion rates.

Figure 4.8. Locations where measurements were made of thickness of corrosion products and underlying shiny steel on edge sections of hull and superstructure fabric on the USS ARIZONA.

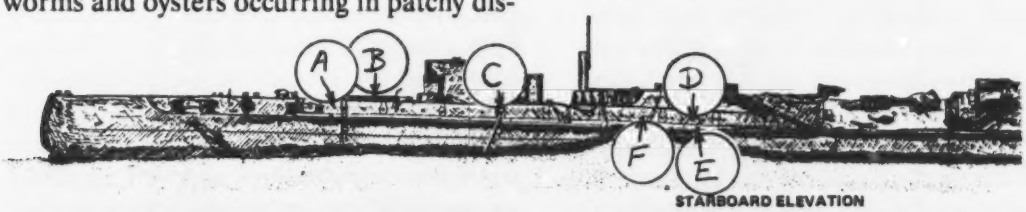
As expected, oxygen levels measured 15 to 16 feet inside interior spaces were substantially lower than ambient values (Table 5). At distances of 8 to 9 feet inside openings, oxygen levels were only moderately lower than ambient, indicating that water volumes within about 10 feet of hull openings are relatively well flushed. Oxygen concentrations were at or less than 1 mg/l at 15-foot distance from opening in 3 out of 6 stations, thus it would be reasonable to assume that most other enclosed volumes in the hull that are distant from openings would also exhibit sub-1 mg/l oxygen concentrations.

Figure 4.9. Locations of points of entry for water -quality measurements made in interior spaces in the USS ARIZONA.

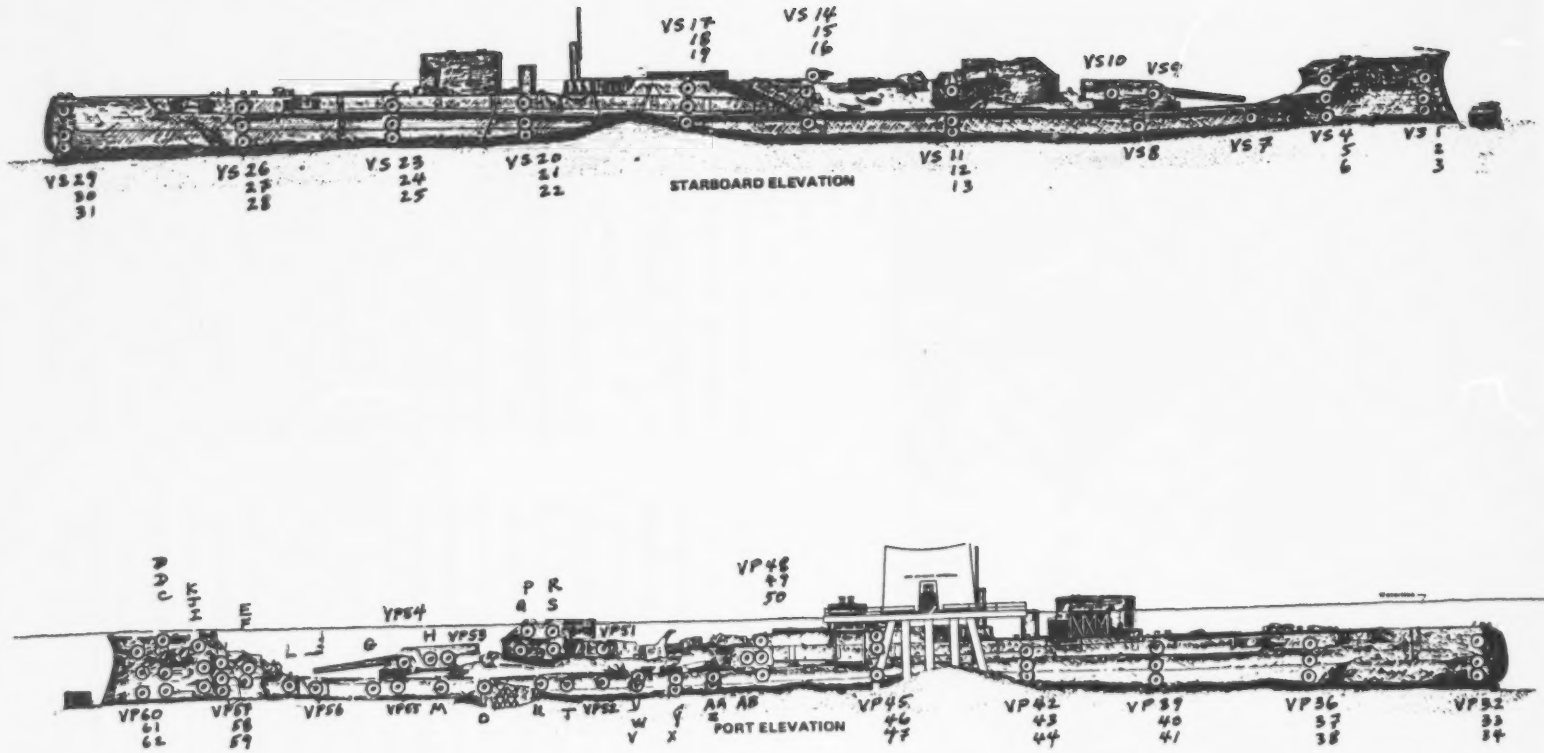
VOLTS	NOTES
.582	Large superstructure surface - @E5 clip - black layer with some white laminations inside.
.578	Objects on wood deck that look like "nuts" measuring about 8"X8"X3" high made of brass or bronze.
.585	Round stack near clip P3.
.596	Large diameter salvage cable about 15' NE of FS20.
.588	Steel nearly exposed on hull by fish nest about 15' SW of FS20.
.590	Gunnel at 6.
.593	Bollard top at clip V7.
.290	Reading in normal salinity seawater at about 5' depth.
.280	Reading in lower salinity seawater near surface. No contact with solid substrates on these two readings.

Figure 4.12. Location of bathycorrometer measurements made on the USS ARIZONA.

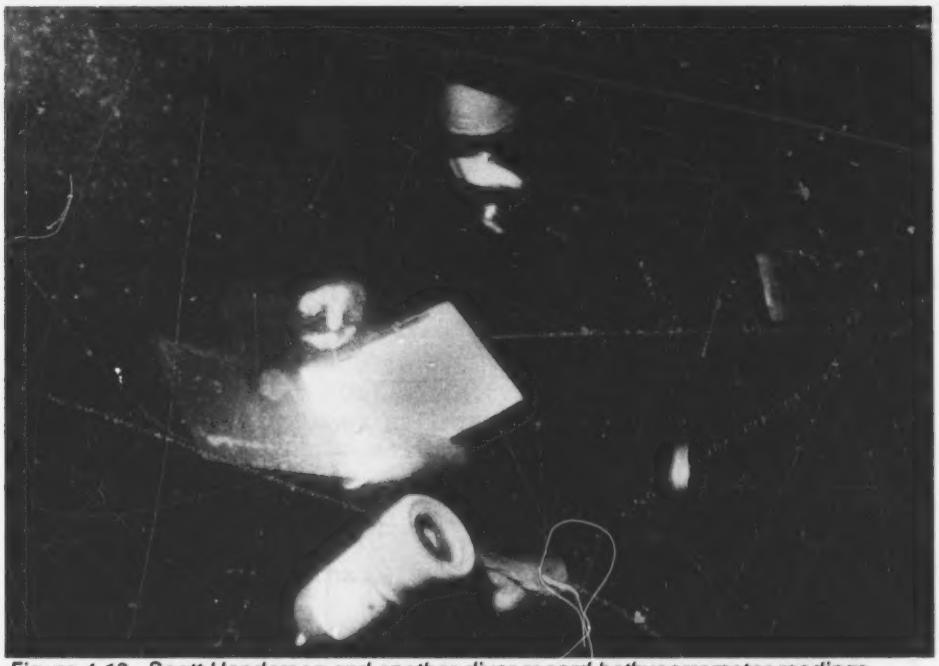
Figure 4.13. Scott Henderson and another diver record bathycorrometer readings. (NPS photo by Larry Murphy)
